**GeddesPhysics Laboratories Memorandum
Failure Modes Analysis Team**

Ryan Evans

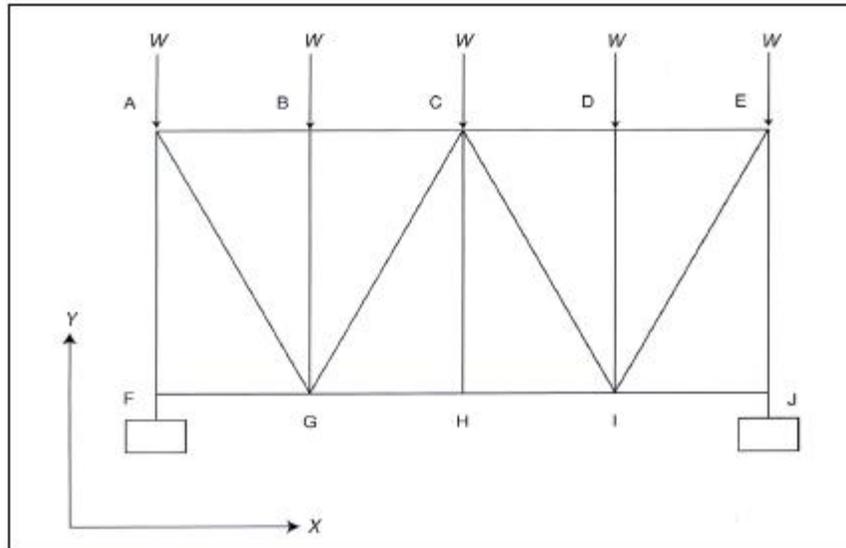
$$F_{BC}(2) + F_{CG}(0) + F_{GH}(0) + W(0) + W(1) - 5/2W(1) = 0,$$

$$F_{BC} = 3/4 W$$

The total force acting on joint C is roughly:

$$(F_x^2 + F_y^2)^{1/2} = (F_{BC}^2 + W^2)^{1/2} = (25/16)^{1/2} W = 1.25 W.$$

$$F_{AB} = 3/4 W$$

The total force acting on joint A is roughly:

$$(F_{AB}^2 + F_{AF}^2)^{1/2} = [(3/4 W)^2 + (5/2 W)^2]^{1/2} = 2.61 W.$$

The total force action on joint A is analogous to joint E.

As determined from the mathematical analysis, joint C, the joint at which the bridge failed, was bearing less weight than joints A and E. By this means, the bridge should not have failed at this point due to a design flaw. The thickness of the gusset was sufficient so it would not buckle under the weight of a normal live load; however, others factors came into play when further analyzing the collapse. For instance, in 1977 and 1998, the thickness of the deck was increased. We are unaware if the decking was evenly distributed. In addition, construction was occurring on the deck of the bridge, adding an additional 287 tons of a static load onto the U10 joint. Also, when studying the manner that the bridge failed, it is apparent that the additional weight caused the bridge to fail.

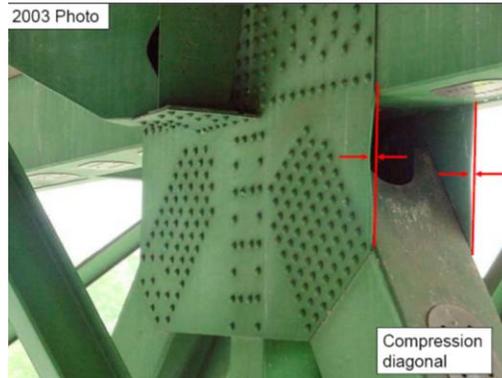
One can see that the gusset buckled, meaning the additional weight created extraneous pressure on the gusset. Because the bridge failed in this manner, it becomes apparent that the initial design of the bridge did not cause the failure; however, when adding the extra decking, an increase in the thickness of the gusset would have prevented the failure of the bridge because buckling would be less likely to occur.
